## South Coast Salmon Bulletin

### October 1, 2021 Escapement Update

## Chinook, Coho and Chum – Area 18 Cowichan River

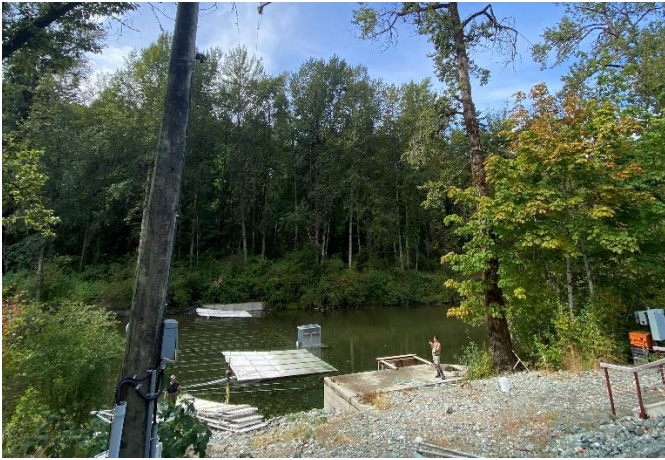
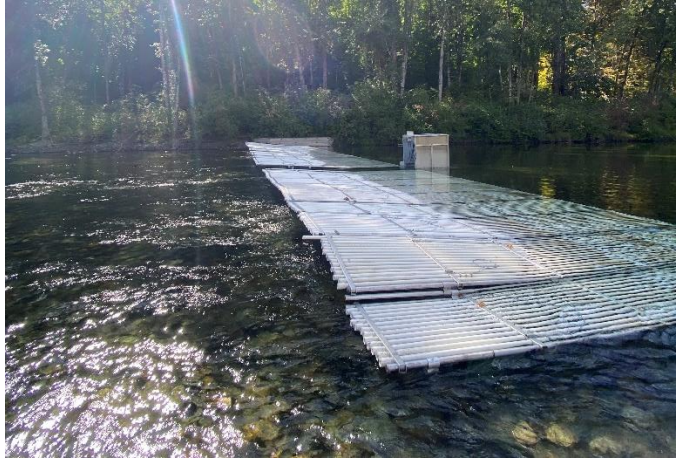
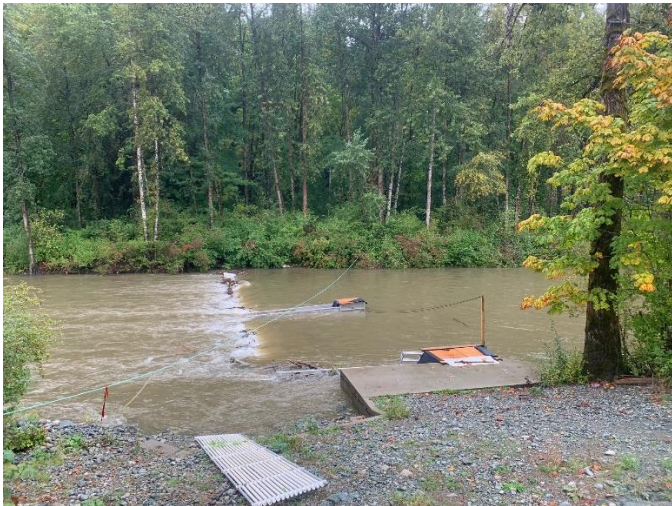
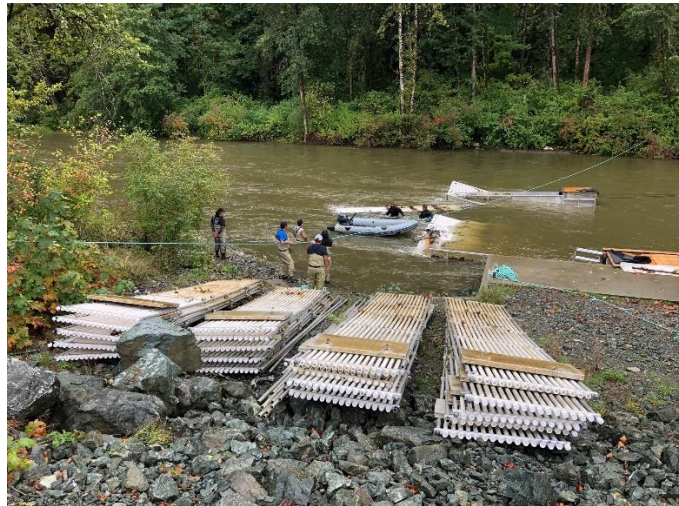
Below are photos of the fence from installation and removal. The top two photos are from September 8<sup>th</sup> when the fence was installed (left) and operational (right). The bottom two photos are from September 30<sup>th</sup> when the fence was underwater from flows exceeding 50m<sup>3</sup>/s (left) and during removal (right).

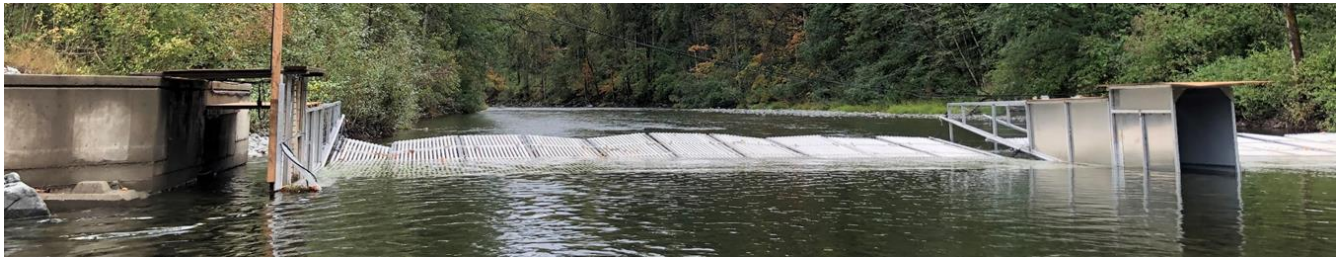
Operations in 2021 remain unchanged from 2020 and only basic maintenance activities were required prior to fence installation. Key infrastructure upgrades at the enumeration fence in 2020 included new Passive Integrated Transponder (PIT) in-river arrays. Utilization of two passageways at the fence was first piloted in 2019. The passageways, one located against the bulkhead and one mid-river, have replaced traditional camera boxes to improve fish migration. Results from 2018 and 2019 indicate that fish strongly prefer the wider passages compared to the traditional camera tunnels. Delays below the fence

have been reduced with the highest single day migration totals observed in 2019 for the 32 year program. Each passageway is instrumented with two under water cameras with motion detection capability as well as LED lights for night time operation.

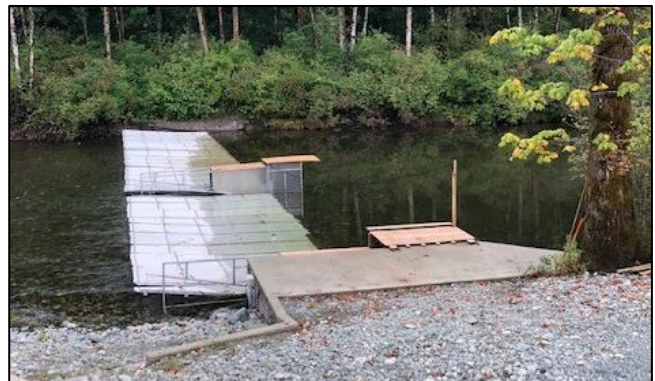
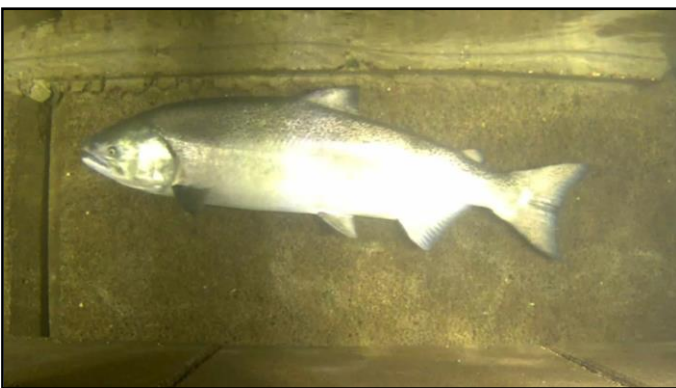
The counting fence is located 150 m downstream of the Allenby Road bridge crossing and is accessed via Church Road on Cowichan Tribes land. The fence funnels migrating fish through two passages where species, size and origin can be evaluated. Cameras are set to record each migration event based on a motion trigger such that periods of inactivity can be skipped efficiently. Crews are present at the fence 24 hours per day to enumerate fish as they move past the cameras as well as to clear debris and maintain equipment as required. The floating panels pivot based on water levels and are expected to remain operational through mid-October. The fence is not designed to withstand high flows and will be removed when the discharge exceeds 30 m<sup>3</sup>/s.

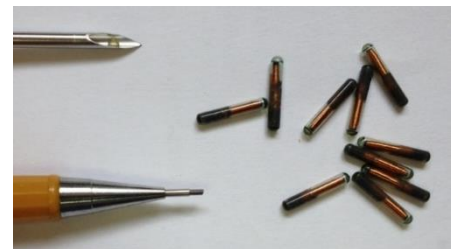
Returning chinook will also continue to be scanned for PIT tags using the in-river arrays at the counting fence and Skutz Falls, as well as during brood stock collection. Temporary arrays have also been installed in the south and north arm channels in order to better understand lower river migration behavior. Over 75,000 juveniles have been implanted with tags since 2014 with funding from the Pacific Salmon Foundation as part of the Salish Sea Marine Survival Project (2013-2018) and more recently the Pacific Salmon Commission. Due in part to the success of this tagging work, a new project has been funded through BCSRIF (BC Salmon Restoration and Innovation Fund) to investigate marine survival Bottlenecks through the first marine winter. PIT tag arrays and tag deployments have now occurred in other ECVI Chinook systems such as Nanaimo, Big Qualicum, Puntledge and Quinsam in addition to ongoing work in Cowichan.

PIT tags operate on Radio Frequency Identification (RFID) technology and do not have a battery. They can be read at short distances (50-150 cm) with an antenna that both charges the tag with a magnetic field and listens for the response. Tag detections are linked to a tagging data base which provides information on the time, location, origin and size of each fish on the day it was tagged. The proportion of tags in the population passing through the fence and/or in brood sets can be used to expand the number of detections on the permanent arrays to a total run size. This can particularly useful in years when the operation of the fence does not cover the entire run time (installed late or removed due to high water).
